**COMPREHENSIVE MOTOR VEHICLE SERVICES AND
CONSULTING
MOTOR VEHICLE FORENSIC ANALYSIS
REPORT**

CMVSC-18-IA-245

-- In the Matter of the Death of Edson Thevenin --

INVOLVED DYNAMIC SUBJECT VEHICLE: 2000 Honda Civic EX Two Door Coupe

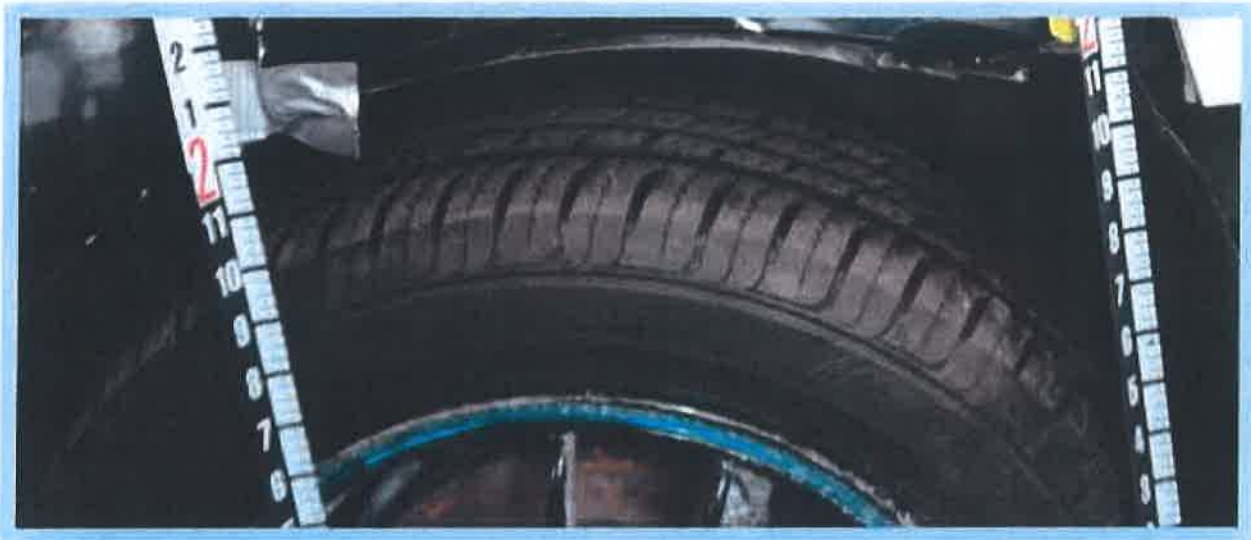
Image No. 9 This photograph of the right front tire of the 2000 Honda Civic operated by Edison Thevenin depicts an example of the condition of the tires of the vehicle. The vehicle autopsy revealed no tire conditions which would have adversely affected the operational characteristics of the 2000 Honda Civic.

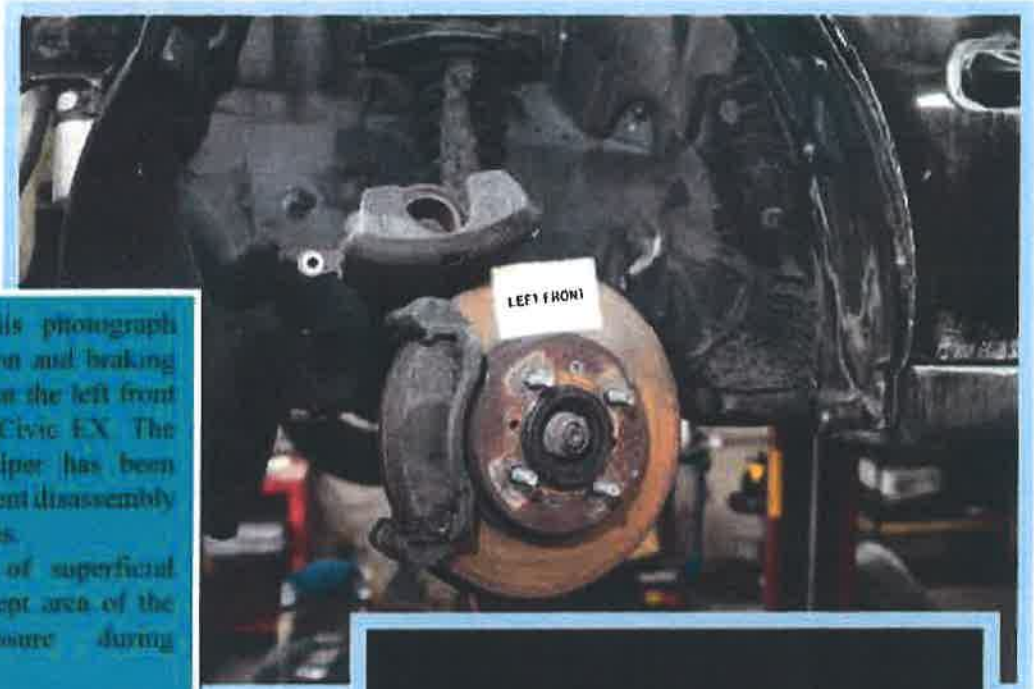
Image No. 10 This photograph depicts the suspension and braking components located at the left front of the 2000 Honda Civic EX. The left front brake caliper has been removed for component disassembly and testing procedures. Note the presence of superficial oxidation on the swept area of the rotor from exposure during impoundment.

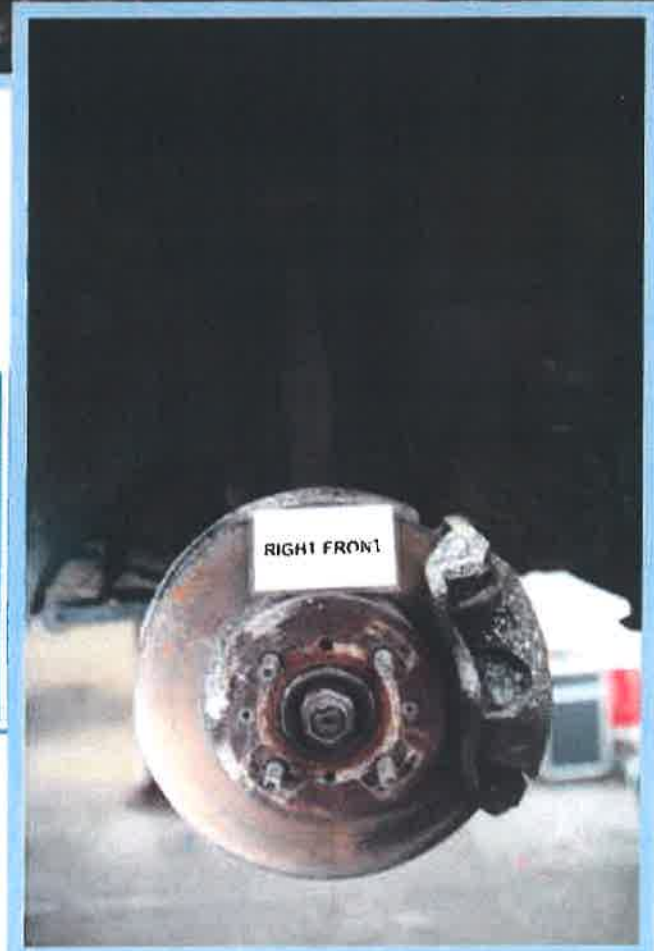
Image No. 11 This photograph depicts the suspension and braking components located at the right front of the 2000 Honda Civic. Note the minimal brake dust accumulation, consistent with no high speed continuous braking during vehicle crash sequence operation.

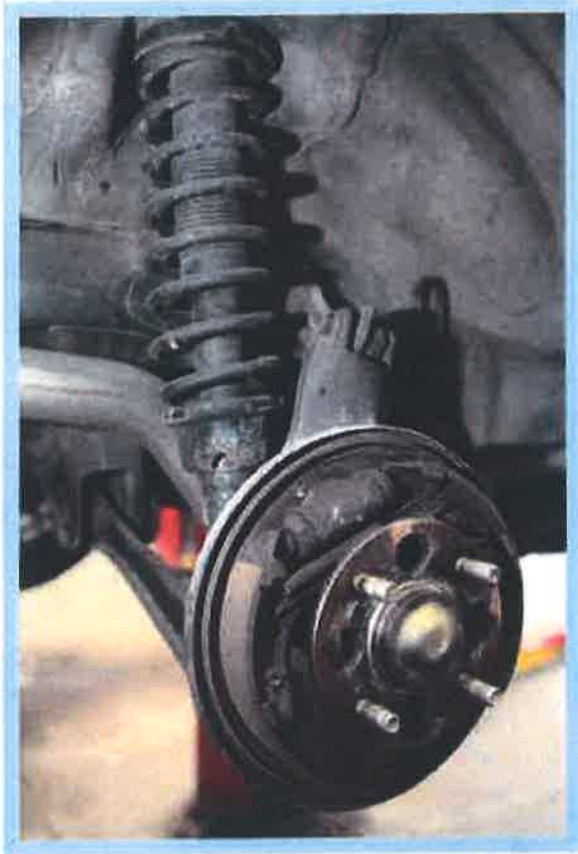
Image No. 12. This photograph depicts the suspension and braking components located at the right rear of the 2000 Honda Civic. Note the intact components, with no wheel cylinder brake fluid seepage.

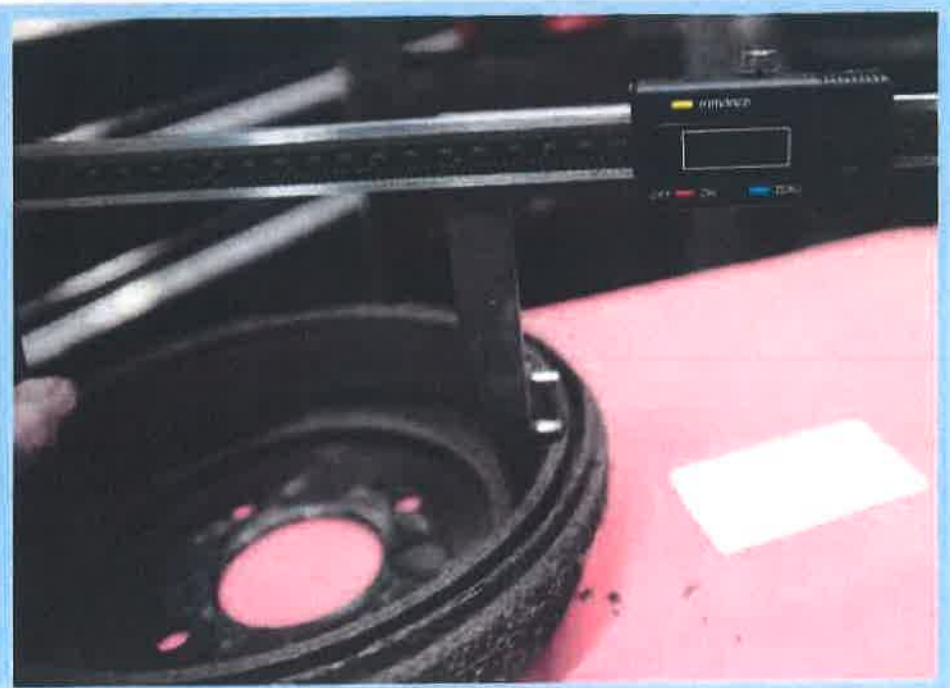
Image No. 13. This photograph depicts the brake drum located at the right rear of the 2000 Honda Civic. Wear measurement readings of the brake shoe contact areas of the brake drum exceeded minimum specifications.

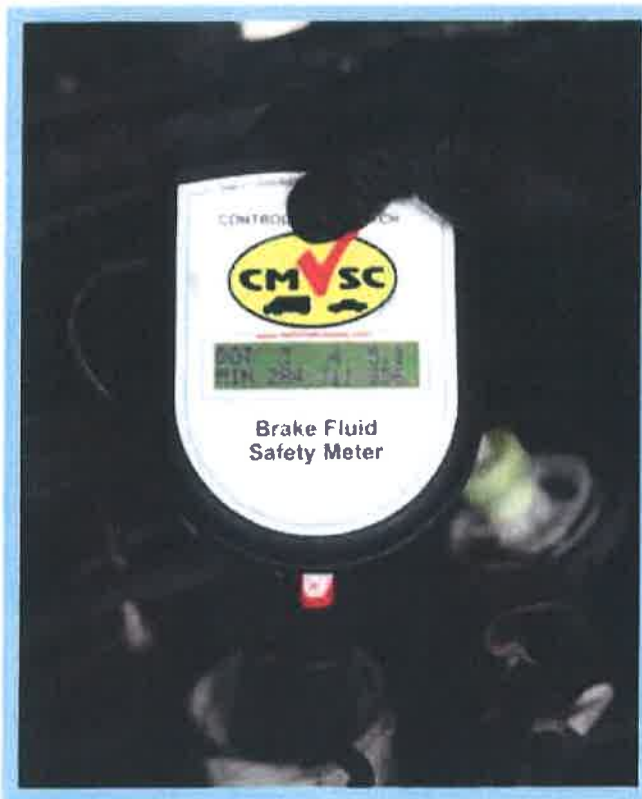
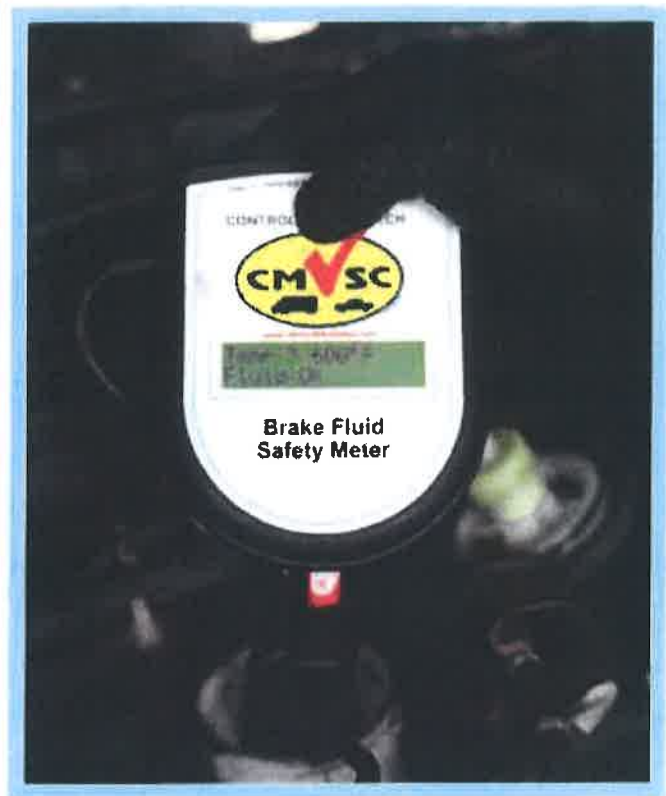
Images No. 14a & 14b: These photographs depict the testing analysis of the brake fluid of the involved 2000 Honda Civic EX to 600 degrees Fahrenheit. The results were that the hygroscopic properties of the brake fluid met/exceeded standards.

The testing analysis revealed proper brake fluid hydraulic properties, sufficient to provide proper braking deceleration of the vehicle.

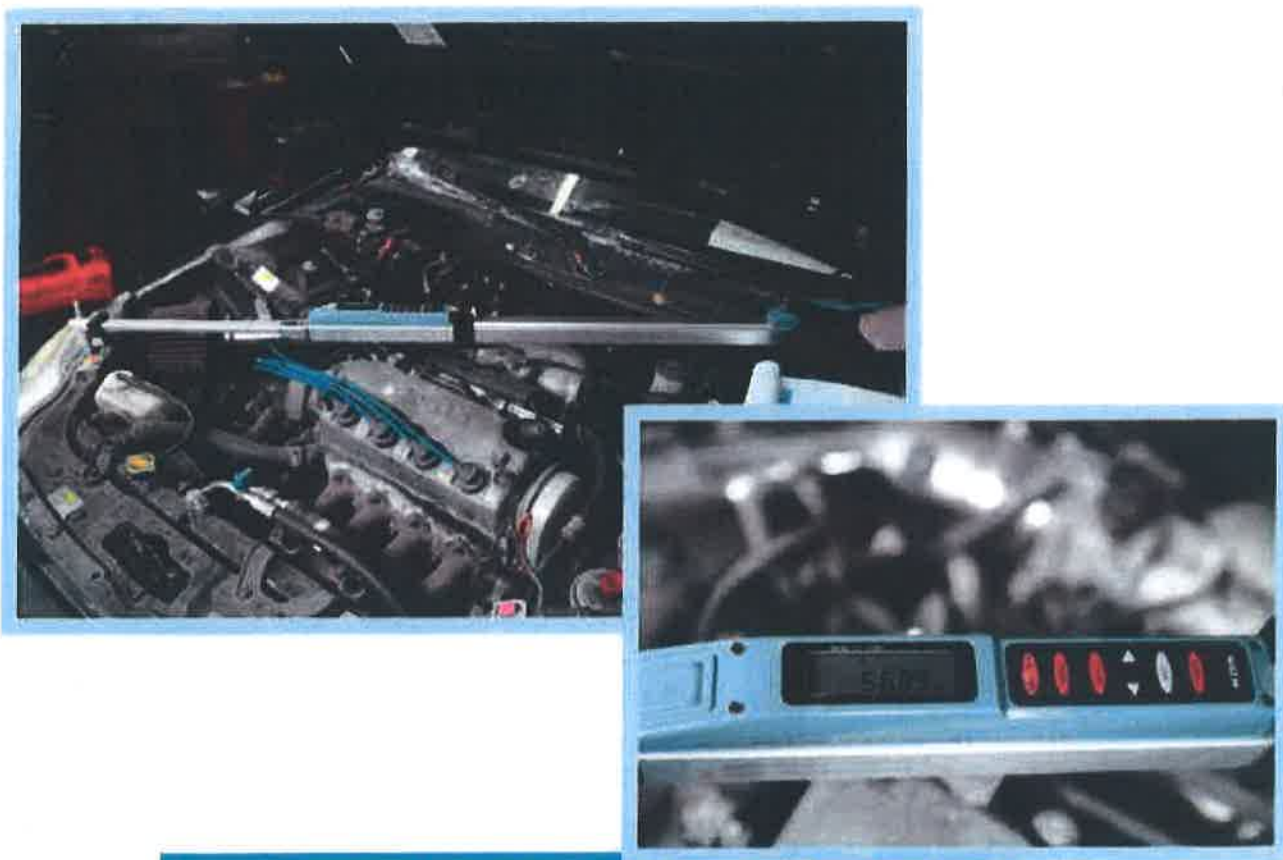
- ◆ Power rack and pinion steering components intact and functional.
- ◆ Steering wheel rotation resulted in positive front wheel/tire steering action; however, normal lock-to-lock transition was limited due to extreme front wheel toe out condition from severity of frontal impact with concrete barrier.
- ◆ No measureable free play -- steering wheel rotation/front tire/wheel steering action.
- ◆ Steering wheel exhibited significant deformation due to unrestrained driver impact forces.
- ◆ No measurable play at tie rod ends.
- ◆ No measurable play at lower front/rear bushings/ball joints, strut joints, or wheel bearings.
- ◆ Front subframe displaced rearward from left front vehicle violent impact with concrete barrier, resulting in diamond dimension deformation of approximately 1.22 inches.

Images No. 15a & 15b These photographs depict the digital strain gauge analysis of the extent of structural damage sustained as the result of the violent impact of the left frontal area of the 2000 Honda Civic with the concrete barrier. The energy of the impact resulted in diamond deformation of the forward Y Axis.

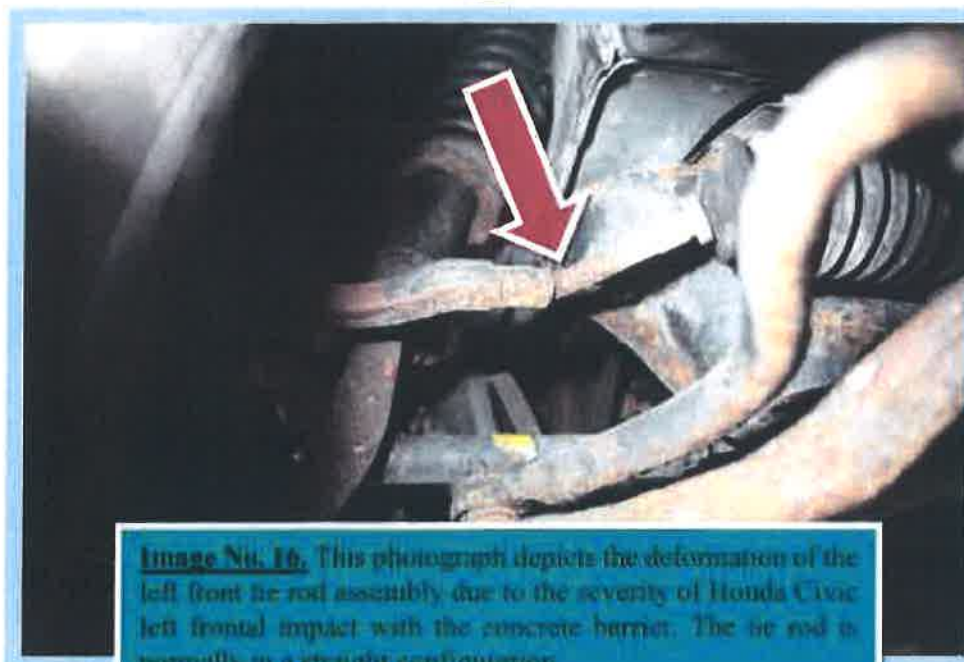
6 Honda specification for front wheel toe condition is .07 inches toe in.

Image No. 16. This photograph depicts the deformation of the left front tie rod assembly due to the severity of Honda Civic left frontal impact with the concrete barrier. The tie rod is normally in a straight configuration.

This deformation as well as subframe deformation resulted in a front wheel toe out condition of approximately 17.4 degrees.

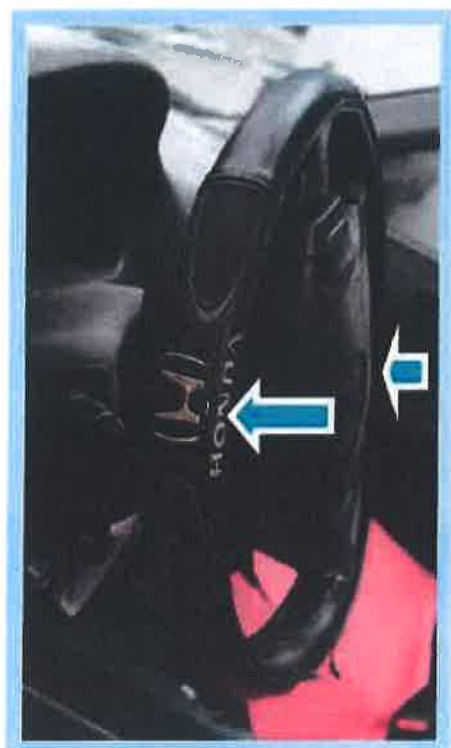
Image No. 17. This photograph depicts the obvious deformation of the steering wheel of the 2000 Honda Civic consistent with the impact energy of unrestrained operator Edison Thivemmi at impact with the concrete barrier.

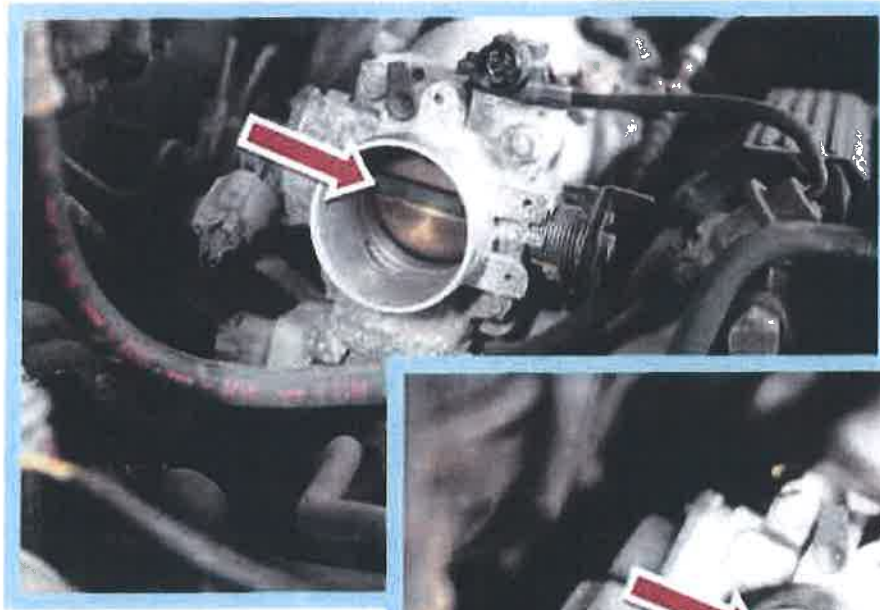
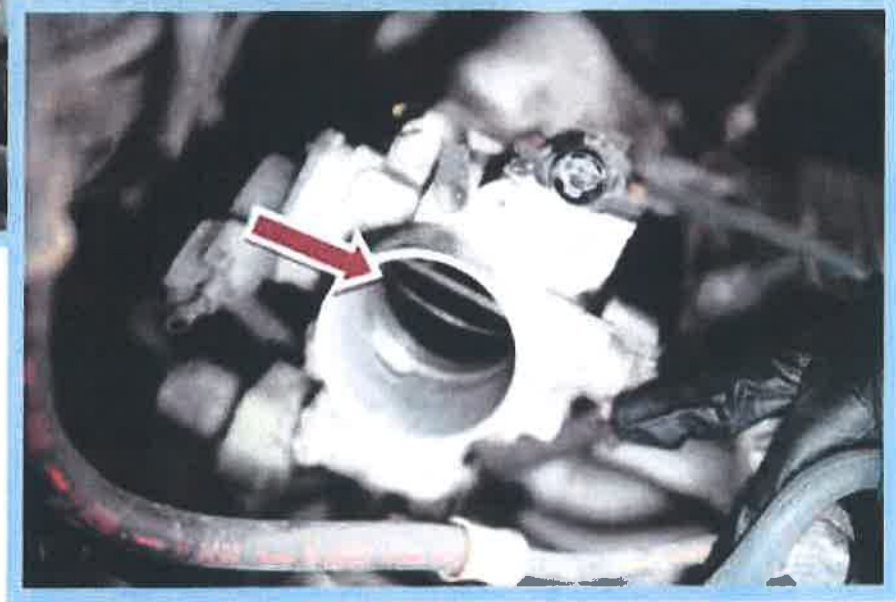
- ✓ The Accelerator Cable operated smoothly with no binding or sticking.
- ✓ The throttle valve shaft of the Throttle Body exhibited no excessive wear or play.

Images No. 18a & 18b: These photographs depict the Throttle Body of the involved 2000 Honda Civic operated by Edson Thevonn. The Red Arrow denotes the Throttle Plate, which is mechanically tensioned to the closed (engine idle) position.

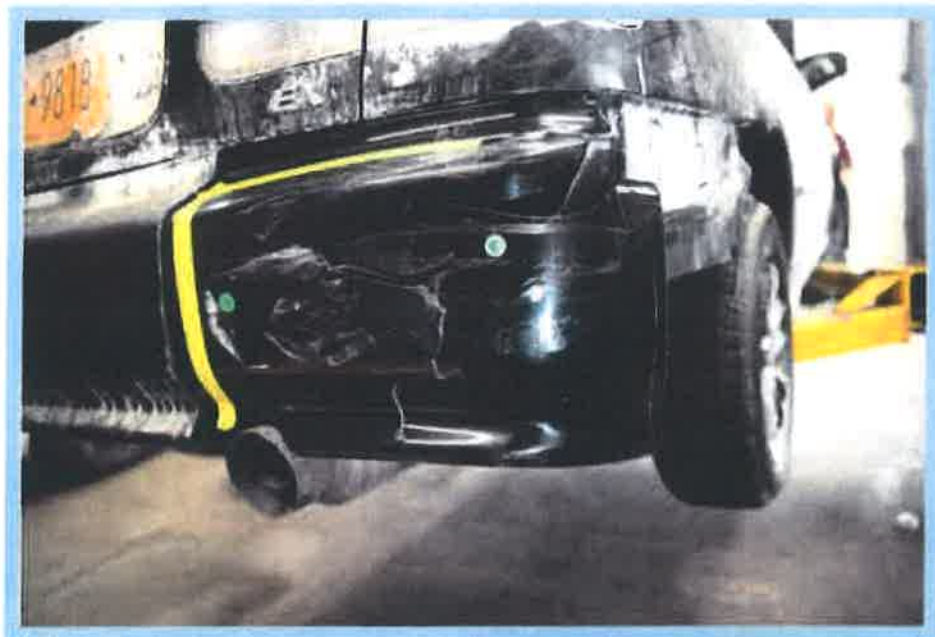
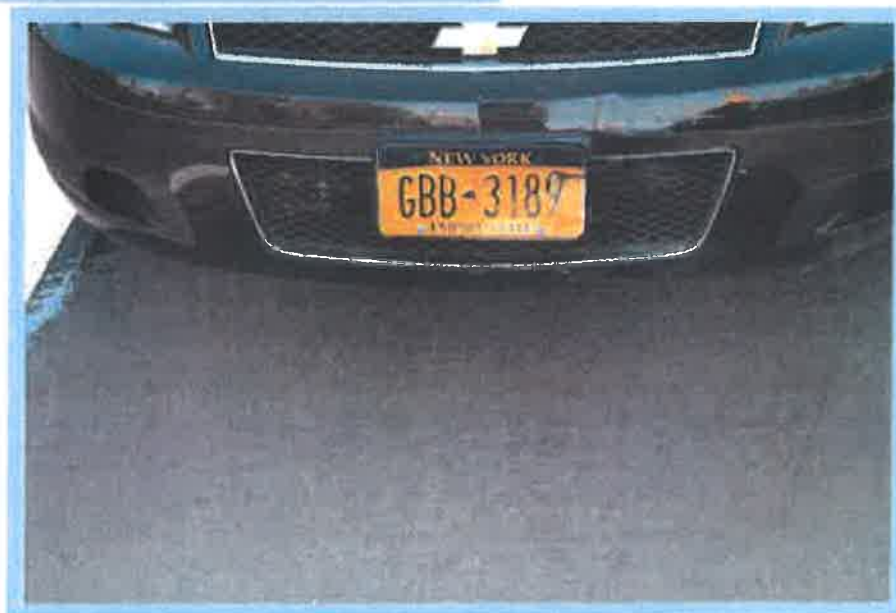
1) **Location of Damage:** Right Rear Bumper Cover.

Description of Damage: Paint scuffing/scratching; paint delamination; fracturing of plastic rear bumper cover material.

Analysis of Damage: Consistent with impact with frontal front bumper cover area of Troy Police Department 2012 Chevrolet Impala as the result of rearward backing trajectory of 2000 Honda Civic.

Images No. 25a & 25b. These photographs depict the impact damage of the right rear bumper cover of the 2000 Honda Civic (top photo), consistent with rear-end (backing) impact with the front bumper cover of the Troy Police Department 2012 Chevrolet Impala (bottom photo).

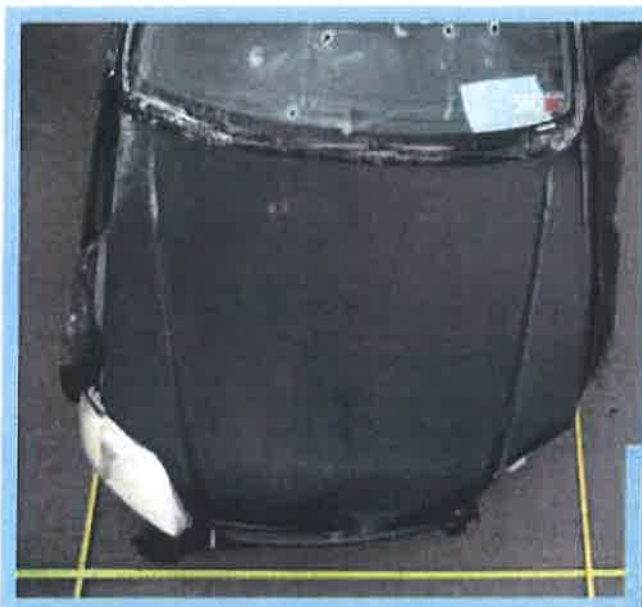
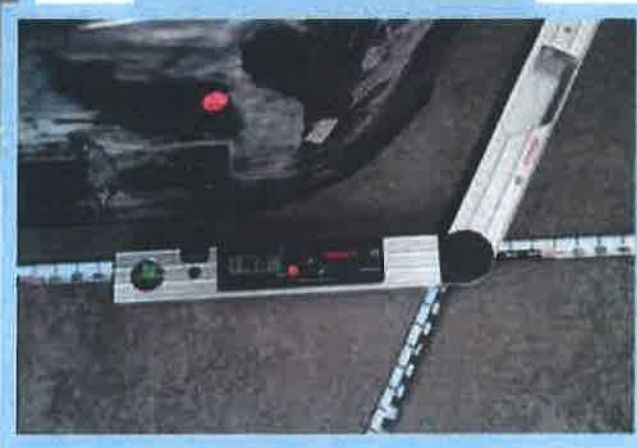
2) Location of Damage: Left Frontal Area.

Description of Damage: Front bumper cover paint scuffing/scratching, front bumper cover detachment; structural damage inclusive of rearward deformation of front subframe assembly; obvious toe out condition of front wheels; left wheelbase reduced approximately 2.09 inches.

Analysis of Damage: Consistent with severity of frontal vehicle impact with concrete barrier of Alternate Route 7 (Collar City Bridge).

Images No. 26a, 26b, & 26c These photographs depict the impact damage of the left front of the 2000 Honda Civic, consistent with the violent concrete barrier impact of April 17, 2016. Utilizing digital measuring equipment, the impact angle was determined to be approximately 118 degrees (side) 78 degrees (front).

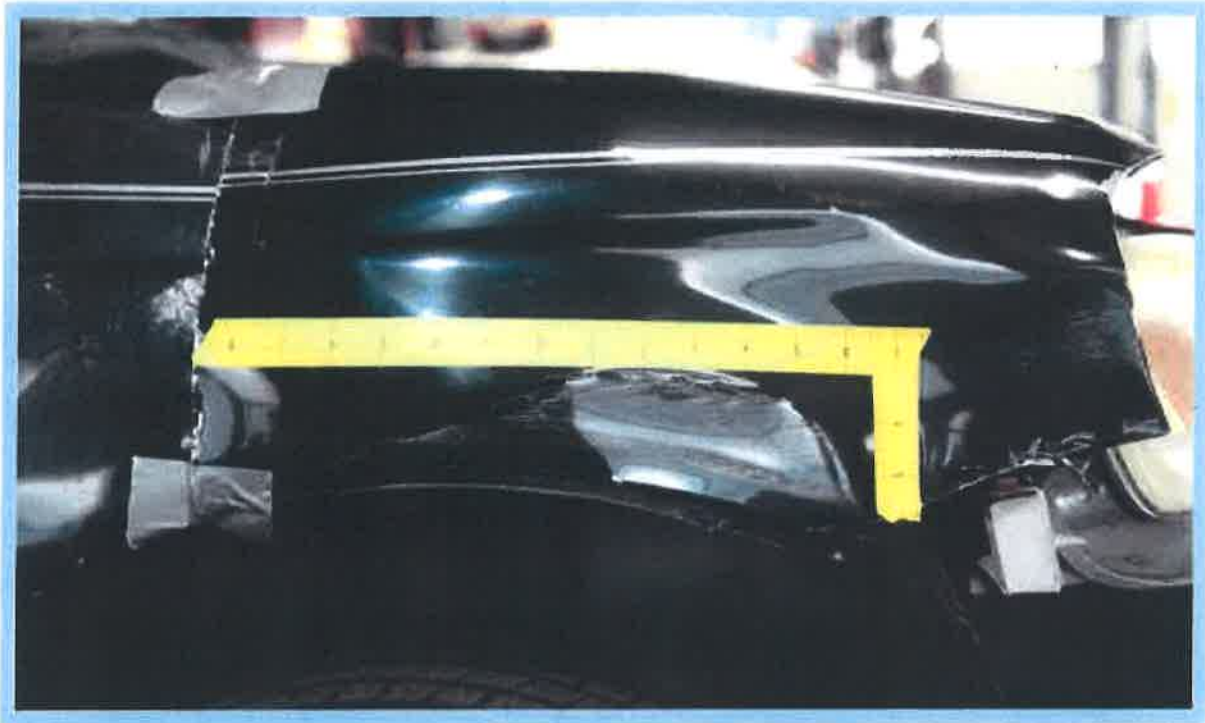
3) Location of Damage: Right Front Fender.

Description of Damage: Paint delamination/striations; paint transfer; inward deformation/stretching of sheet metal.

Image No. 27 This photograph depicts the impact damage sustained by the right front fender of the 2000 Honda Civic, consisting of paint delamination, paint transfer, paint striations, and significant metal deformation-stretching. Digital microscopic analysis revealed that the paint striations were that of left-to-right in the photograph (rear-to-front on the vehicle).

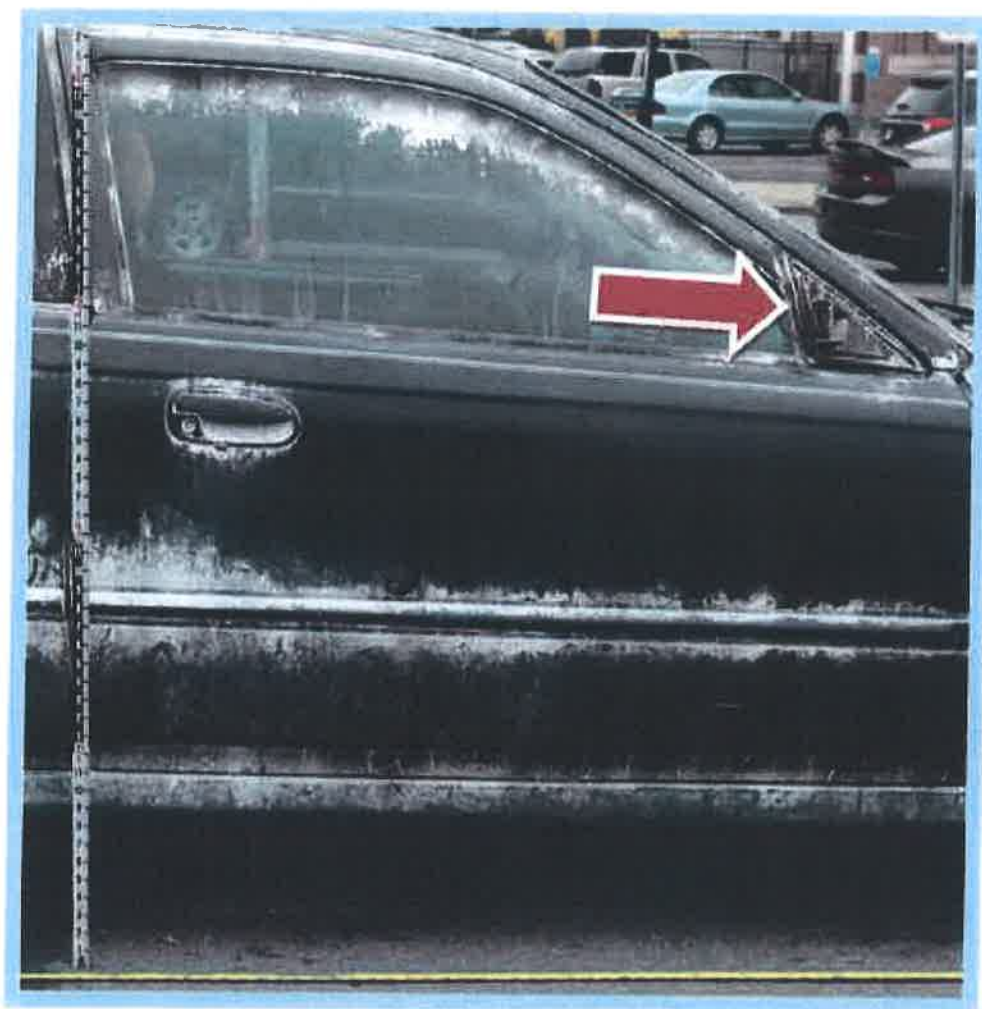
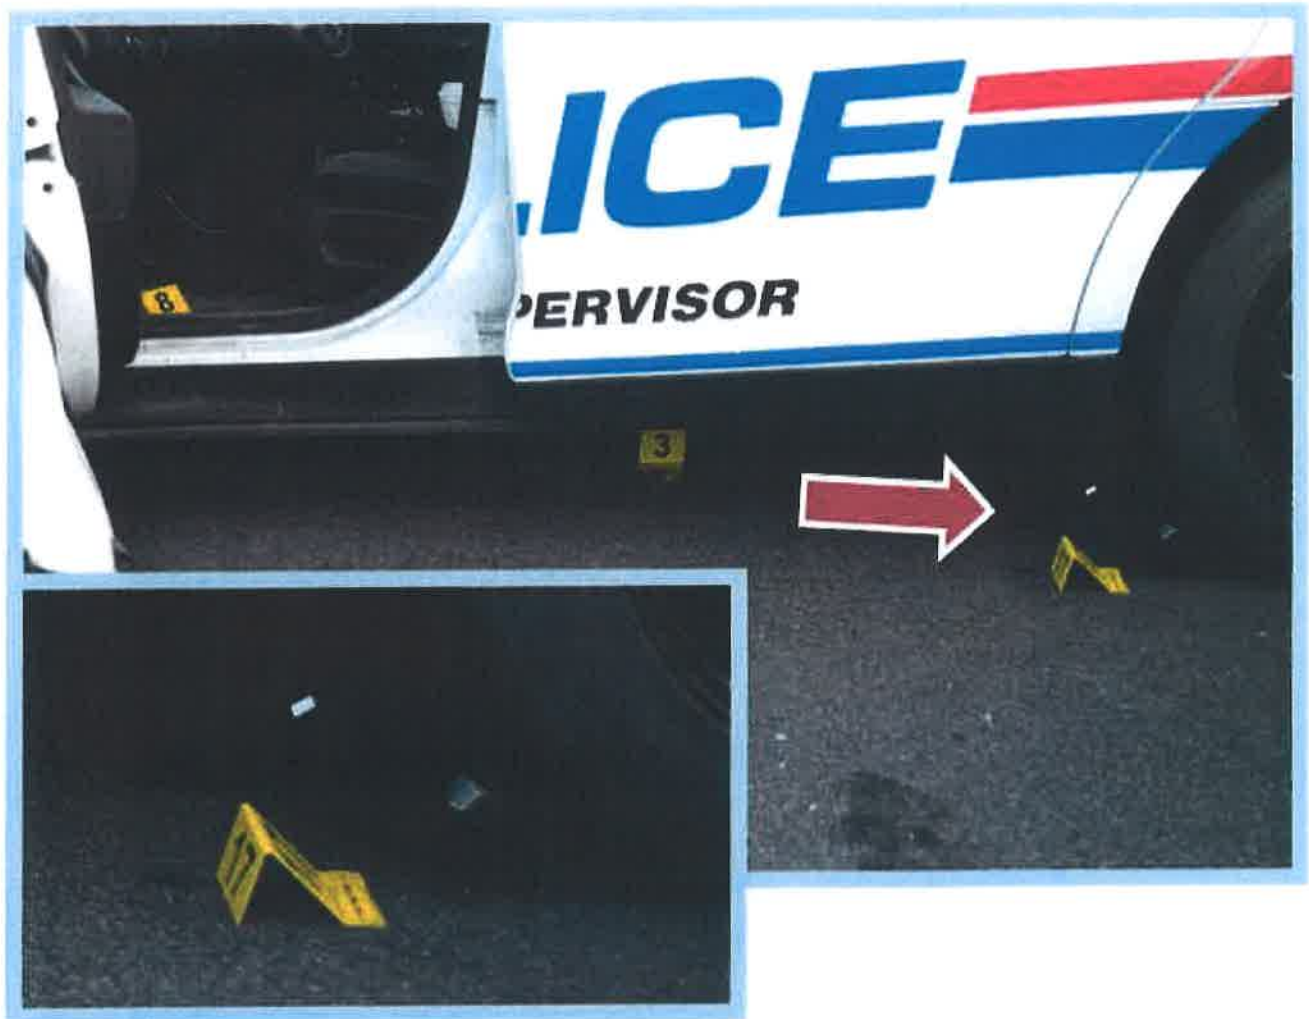
4) Location of Damage: Right Outside Rearview Mirror.

Description of Damage: Forcefully detached in forward trajectory. Paint chipping/striations/scuffing.

Images No. 28a, 28b, & 28c: These photographs depict the right outside rearview mirror location and mirror of the 2000 Honda Civic. The previous page photo denotes the location of the mirror on the vehicle prior to detachment, while the two photos above denote the trajectory final rest location of the mirror in the area of the front of the left rear tire of the 2013 Ford Taurus police cruiser operated by Troy Police Sergeant Randall French at the scene of the April 17, 2016 incident. The mirror exhibited paint striations chipping, with no evidence whatsoever of having been run over by a vehicle tire.

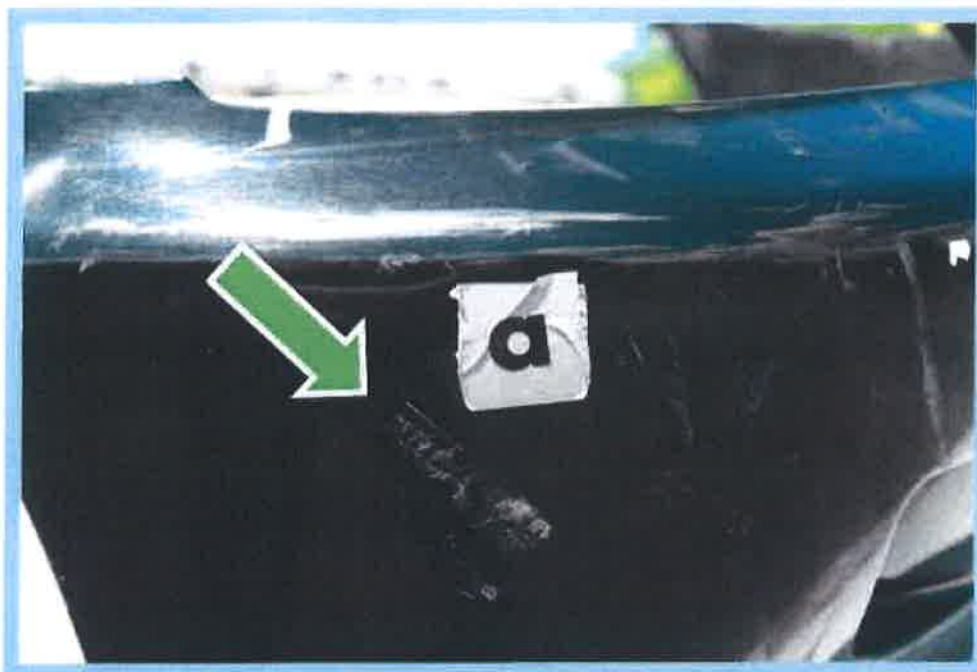
5) Location of Damage: Front Bumper Cover, Right Side (forward of right front tire).

Description of Damage: Paint transfer, striations, scuffing.

Images No. 29. This photograph depicts the right front bumper cover of the 2000 Honda Civic, directly ahead of the right front tire. The Green Arrow denotes paint transfer and scuffing, with striations also present.

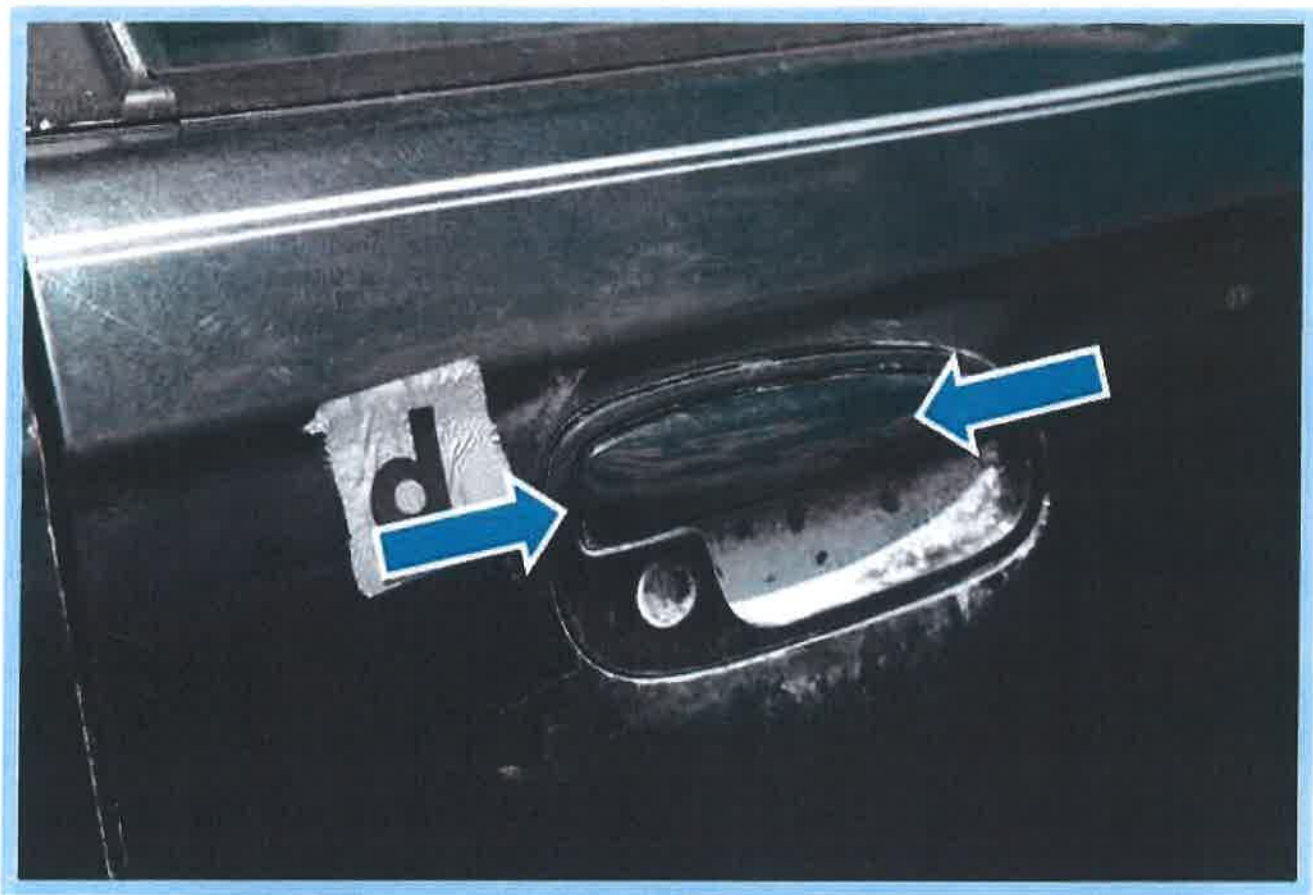
6) Location of Damage: Right Outside Door Handle.

Description of Damage: Paint striations, scuffing.

Images No. 20 This photograph depicts the right outside door handle of the 2000 Honda Civic, directly ahead of the right front tire. Distinctive scuffing was apparent on the paint surface of the door handle forward of the left Blue Arrow, with striations present in the approximate area between the two Blue Arrows. The direction of the damage was left-to-right in the photograph (rear-to-front on the vehicle).

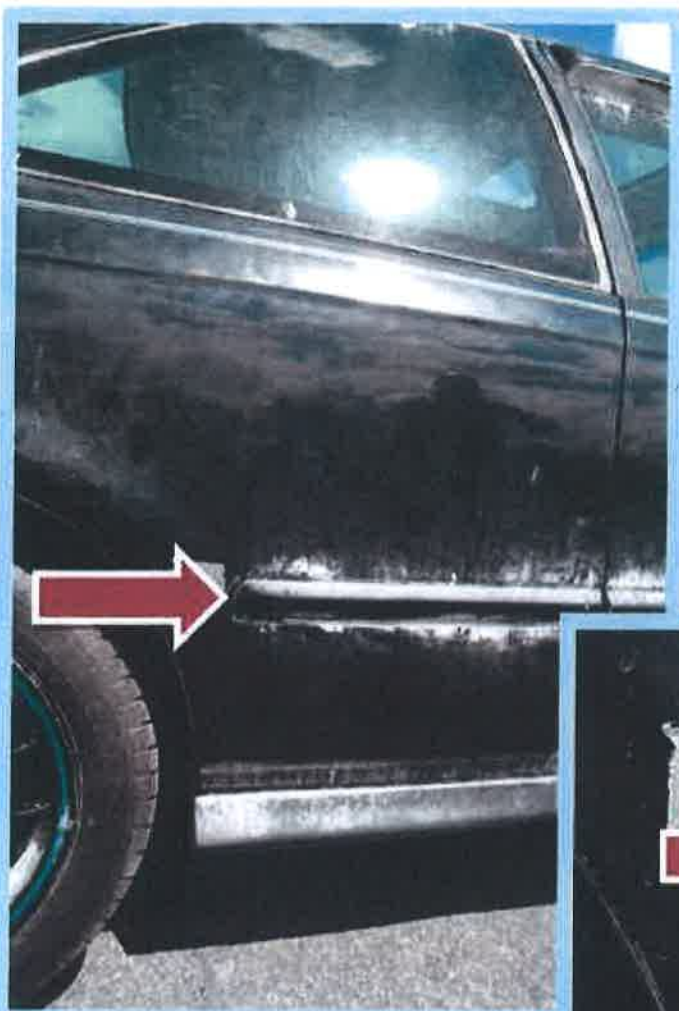
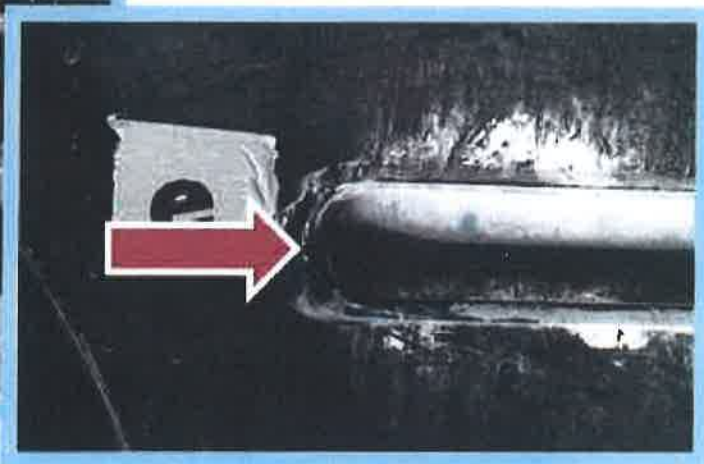
7) Location of Damage: Right Rear Quarter Panel Side Guard Molding.

Description of Damage: Material striations/scuffing; material friction wear.

Images No. 31a & 31b. These photographs depict the described damage present at the right side quarter panel side guard molding of the 2000 Honda Civic. Note the obvious friction wear (Red Arrows). The direction of the damage was left-to-right in the photograph (rear-to-front on the vehicle).

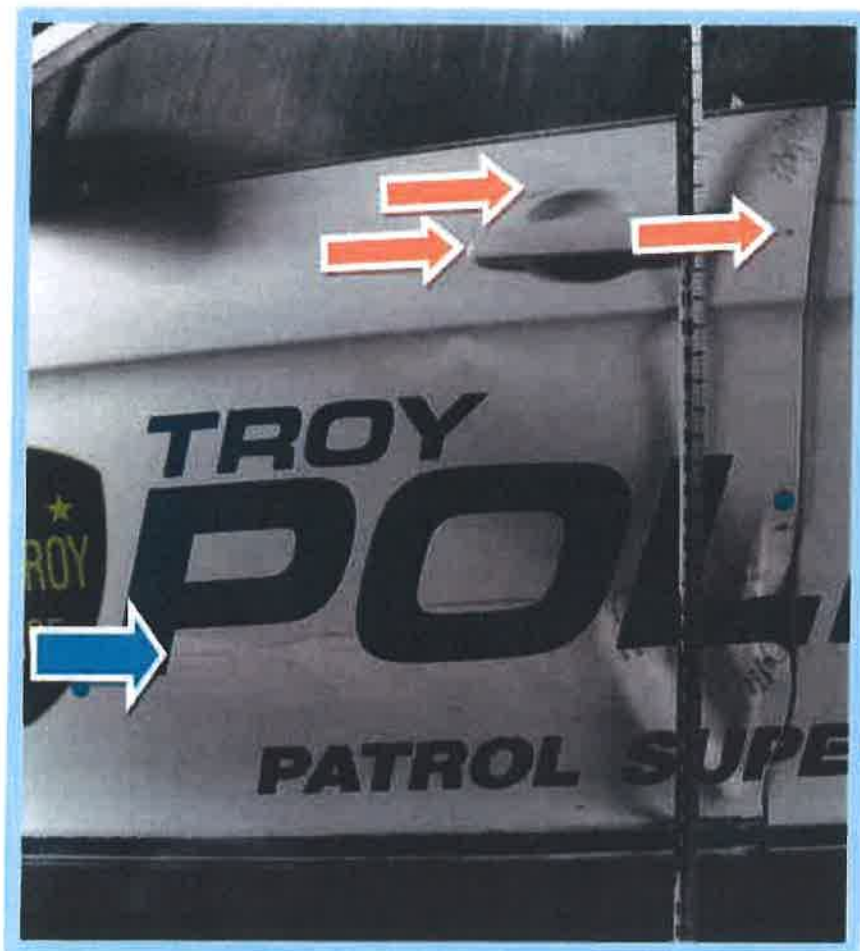
1) **Location of Damage:** Left Front Door, Outer Panel.

Description of Damage: Paint transfer; striations/scuffing; significant outer steel door panel deformation inclusive of creasing, indentation, and buckling; scuffing at outside door handle location.

Image No. 32a. This photograph depicts the described substantial contact damage present at the left front steel door panel of the 2013 Ford Taurus. Note the obvious panel deformation in the area of the vertical tape measure. The Orange Arrows denote scuffing transfer at the leading edge, exterior surface, above, and rearward of the outside door handle. The initiation and direction of the damage was that of the Blue Arrow, left-to-right in the photograph (front-to-rear on the vehicle).

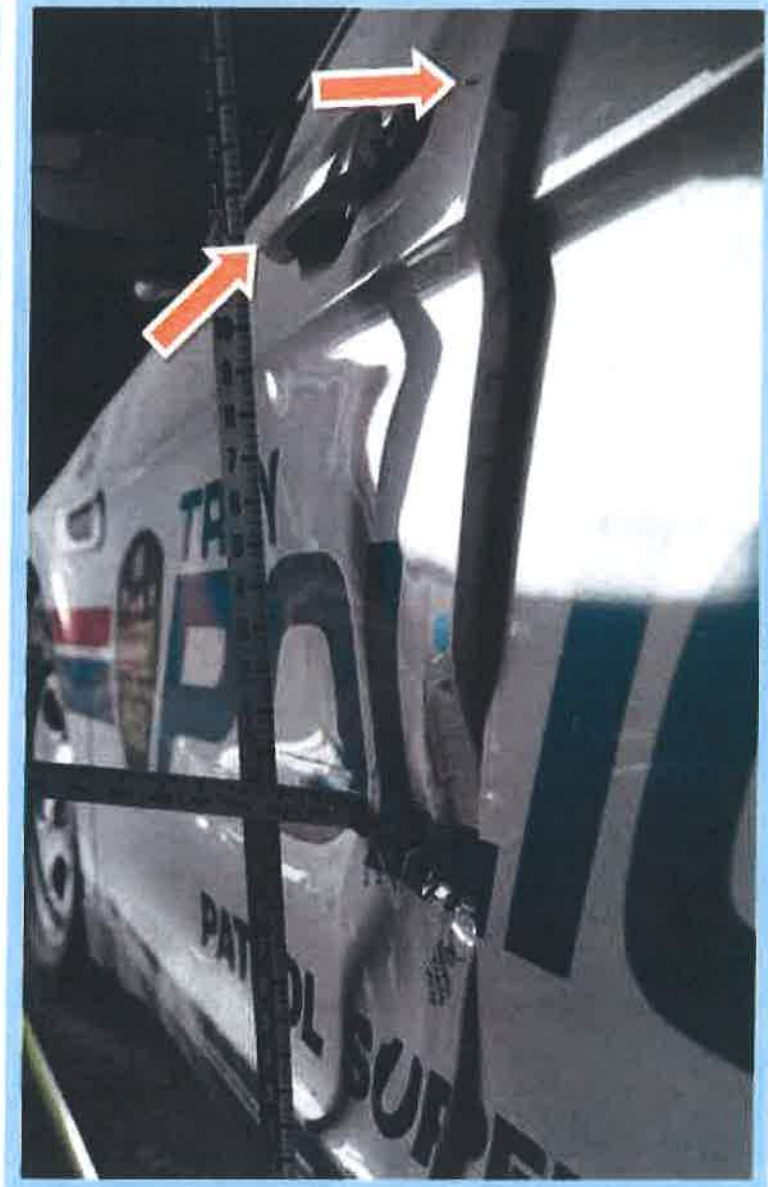
Image No. 32b. This photograph depicts the described substantial contact damage present at the left outer steel door panel of the 2013 Ford Taurus. Note the significant intrusion and panel buckling due to impact. Also note the scuffing present on, and to the rear of the exterior door handle (Orange Arrows). The referenced exterior door handle was displaced slightly rearward from front-to-rear forces.

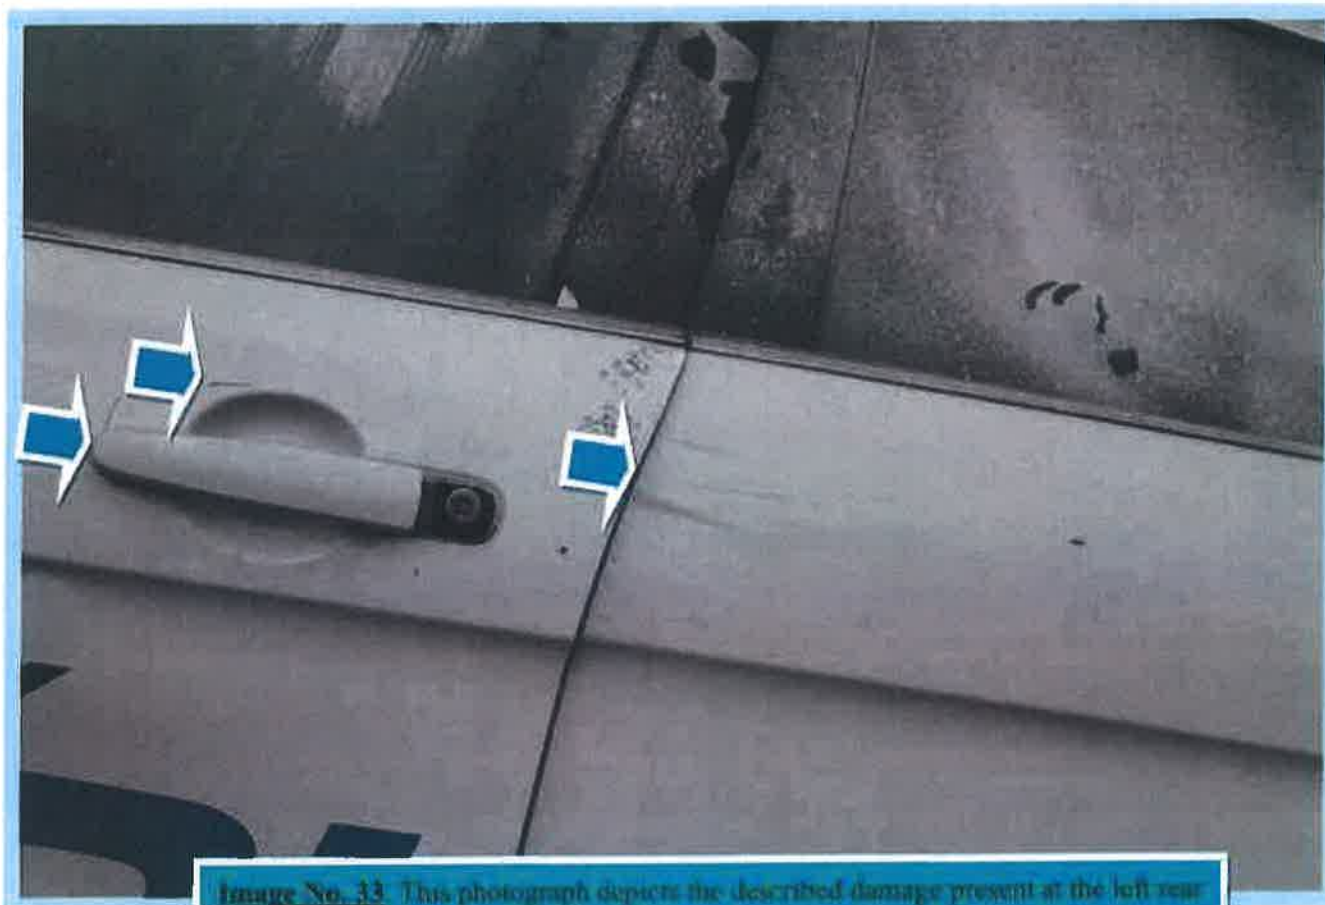
2) Location of Damage: Left Rear Door, Upper Forward Outer Panel.

Description of Damage: Striations/scuffing/transfer -- continuous rearward from left front outer door handle damage.

Image No. 33 This photograph depicts the described damage present at the left rear door upper forward outer panel of the 2013 Ford Taurus. Note the obvious scuffing/transfer (Blue Arrows). The direction of the damage was left-to-right in the photograph (front-to-rear on the vehicle).

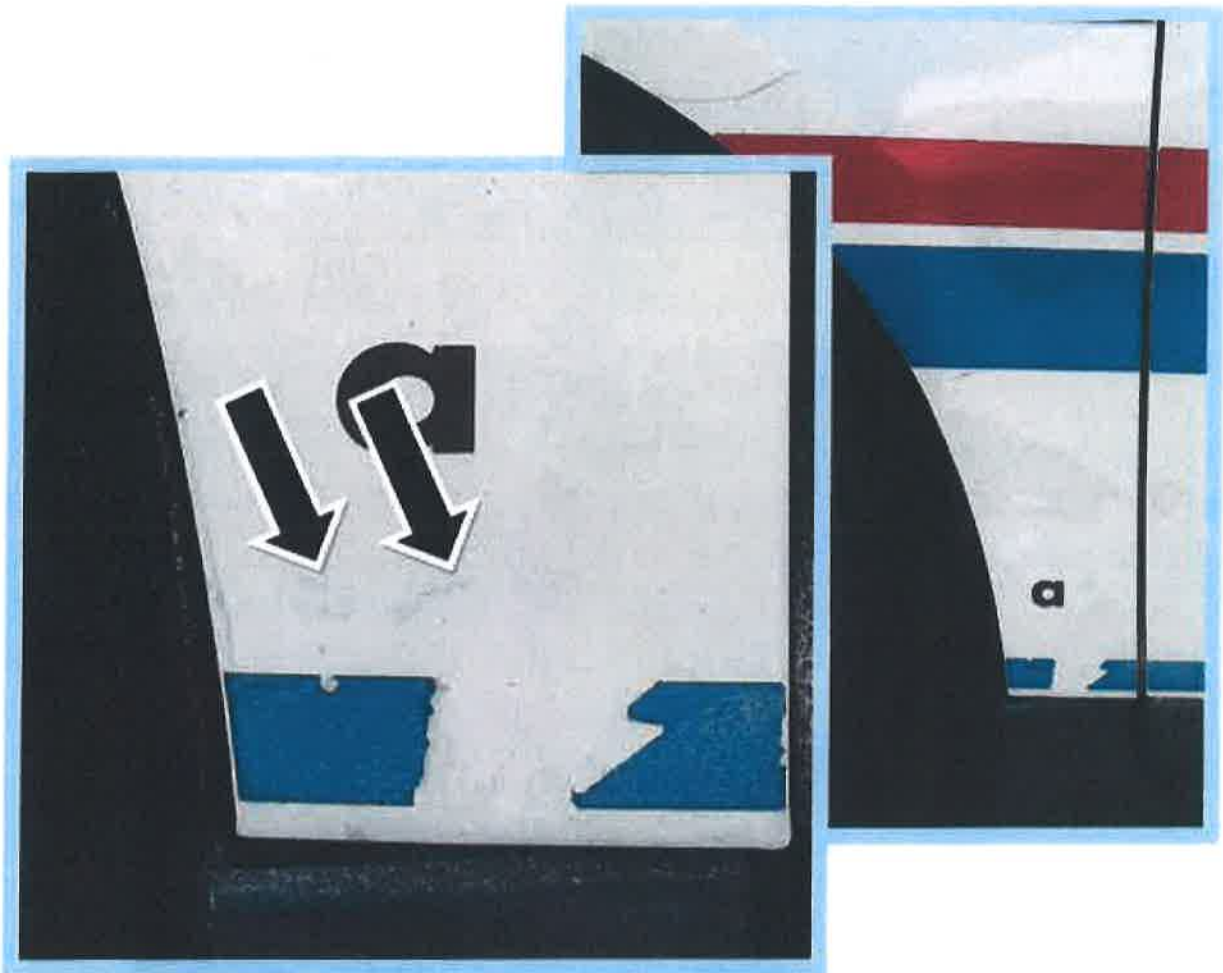
3) **Location of Damage:** Left Front Fender, Lower Rear Section.

Description of Damage: Striations/scuffing/transfer.

Image No. 34 This photograph depicts the described damage present at the left rear lower front fender panel of the 2013 Ford Taurus. Note the obvious scuffing/transfer (Black Arrows).
